1ST ANNUAL SIBYL MEETING
Aristotle University of Thessaloniki
Thessaloniki, Greece, 15th – 16th February, 2016

Task C: Rapid and low-cost in-situ building vulnerability assessment (field work and preliminary results)

Dr. Sergey Tyagunov, Prof. Yuri Petryna
Technical University of Berlin, Germany

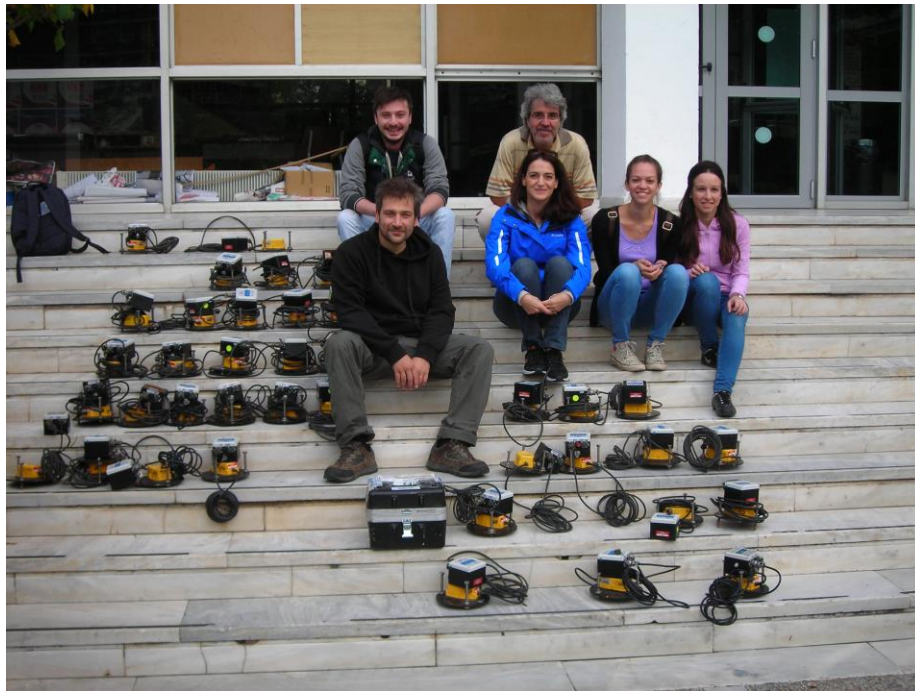
Ambient vibration measurements, system identification and modal analysis for the building of the Faculty of Philosophy

Sensors and time of vibration measurements (September/October 2015)

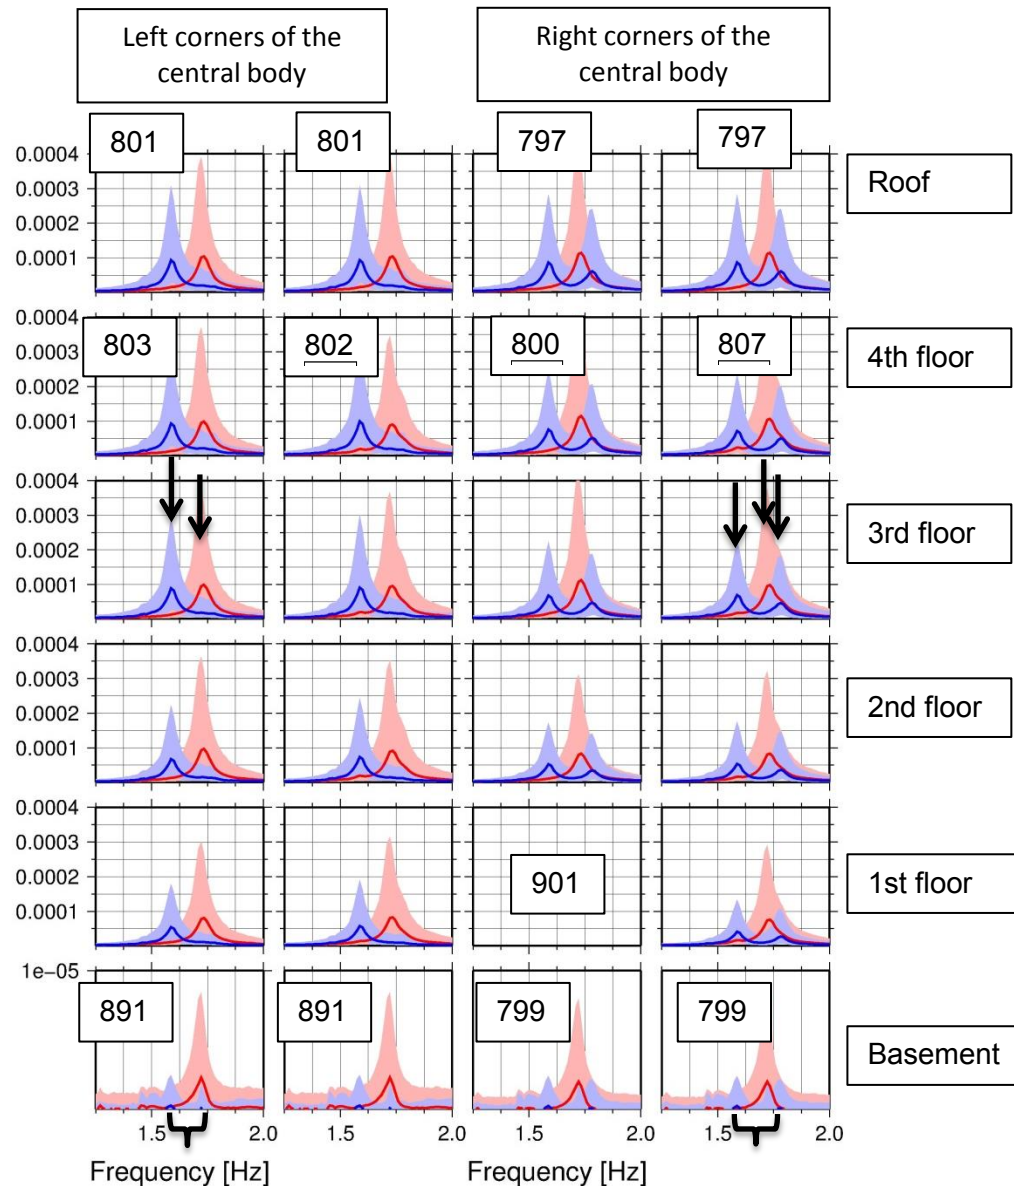
The vibration spectra in the central part of the building

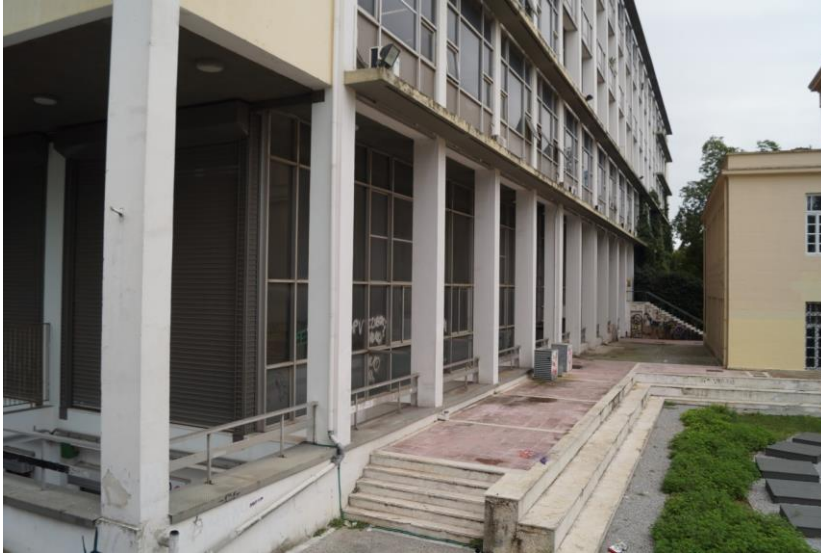
In-situ structural survey and data collection

← One additional storey detected
